Potential Physical Effects of Any Future 1886 Type Eruption From Tarawera Volcano On The Bay of Plenty Region

A thesis
submitted in partial fulfilment
of the requirements for the degree
of
Master of Science in Geology
at the
University of Canterbury
by
Scott Trevor Barnard

UNIVERSITY OF CANTERBURY

2003

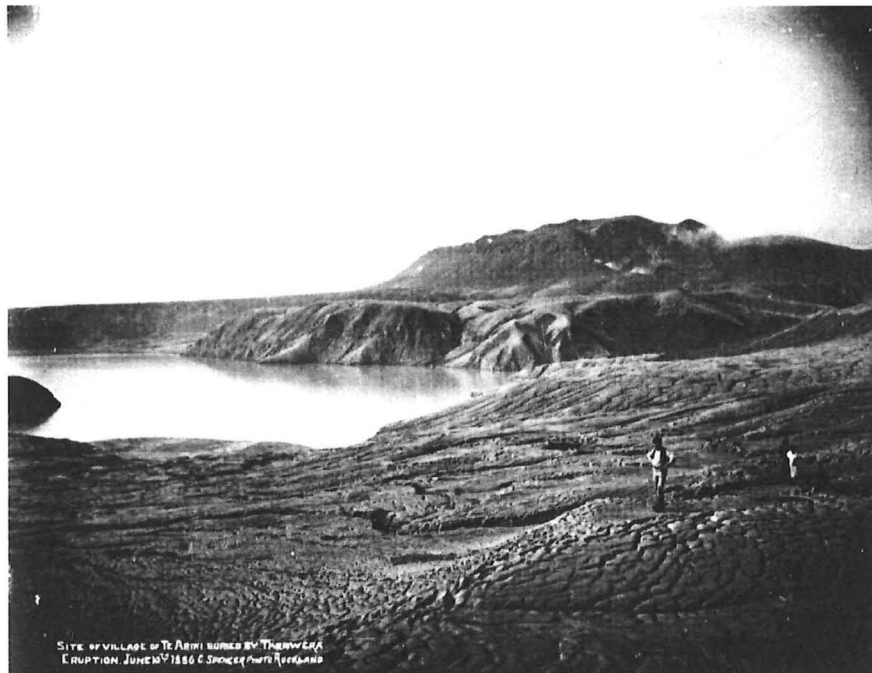
Figure 2.1 The site of the village of Te Ariki after the eruption. Photograph by C. Spencer, 27 July, 1886

The morning of 10 June 1886 revealed a landscape around Tarawera that was completely changed from the day before. Thick deposits of ash, mud and scoria blanketed the countryside, fissures had opened up, trees were gone, or at the least their foliage was stripped. The villages of Te Ariki and Moura were completely destroyed, not even leaving a trace of their existence (figure 2.1)

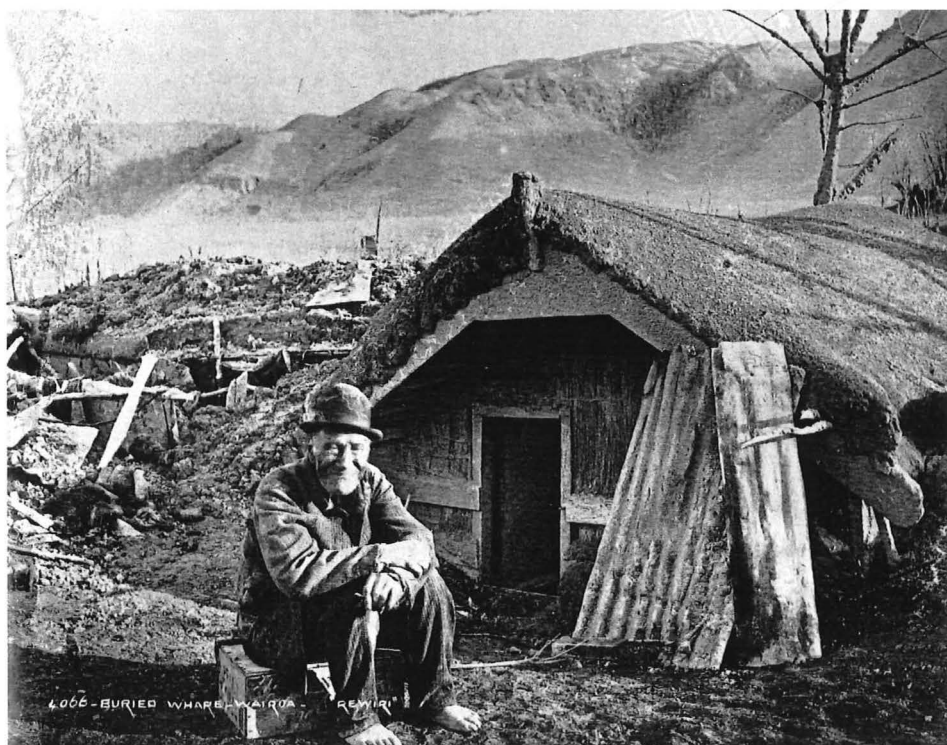
Figure 2.3 Tephra at Te Wairoa, local resident “Rewiri” and his whare. Photograph by A. Ryan, 13 June, 1886.

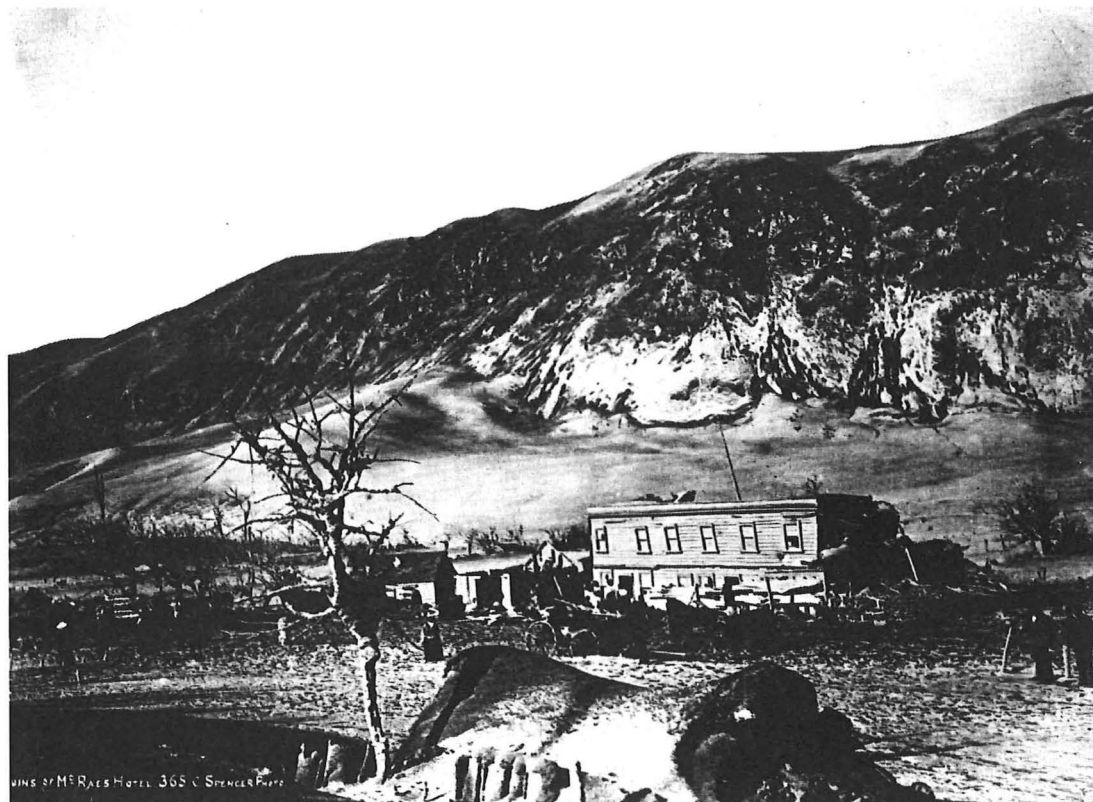
Figure 2.4. The ruins of the Rotomahana hotel, 13 June 1886. Photograph by A. Ryan

ejecta was also reported to have broken windows in the Rotomahana Hotel (Humphries, 1886). This can be seen in photographs taken on the 13 June, 3 days after the eruption (Keam, 1988).

The roof and verandah of this hotel were both to fail due to the accumulation of material, the collapse of the latter killing English tourist Edwin Bainbridge (Keam, 1988). Before the collapse of the main part of the roof of the hotel, the detached kitchen and pantry had already collapsed, as had the bar (McRae, 1886a).

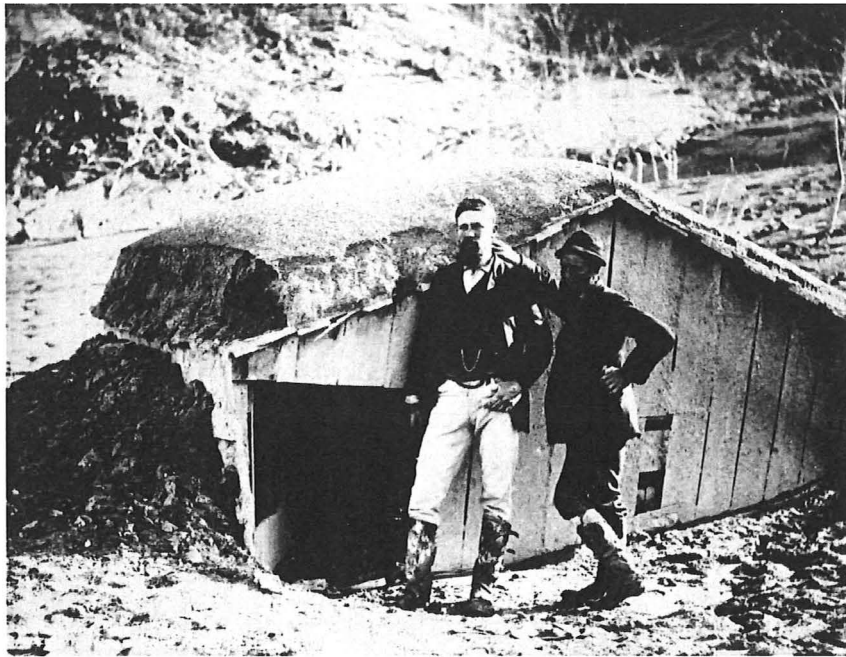
Figure 2.5 Tephra accumulation on the Haszard family hen-house. Photograph by C. Spencer, 8 July, 1886

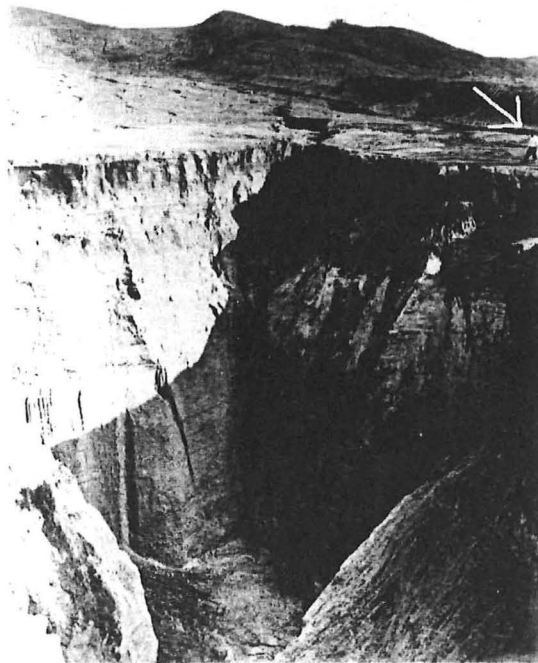
Figure 2.7: Subsidence on the Te Wairoa Road. Photograph by J.C. Blythe, July, 1886

This route experienced further problems in mid July, with subsidence occurring between Tikitapu and the ridge before Rotorua. This took place on a dramatic scale, contemporary photographs and drawings illustrating gaping fissures opening across the road.

One of these fissures was estimated by S. Percy Smith (1887) to be about 90 ft deep (27 m), a figure which appears accurate given the scale of the figure seen on its edge in figure

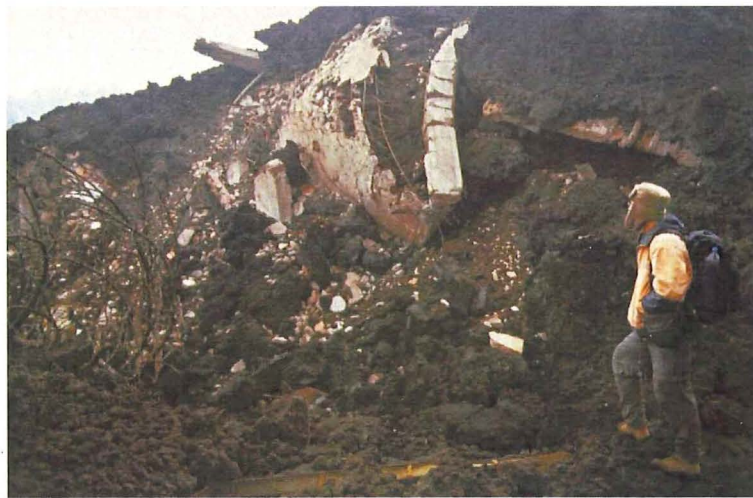
Figure 3.2 Le Betulle Hotel Remains (Photograph by M. Fulle)

Several aa lava flows were emitted during the eruption. These caused some damage to forestry plantations and infrastructure on the slopes of the volcano, as they flowed downslope, destroying everything in their path. Damage began with the destruction of a ski school and the hotel “Le Betulle” at Piano Provenzana by lava flows which began on 27 October, the first day of the eruption.

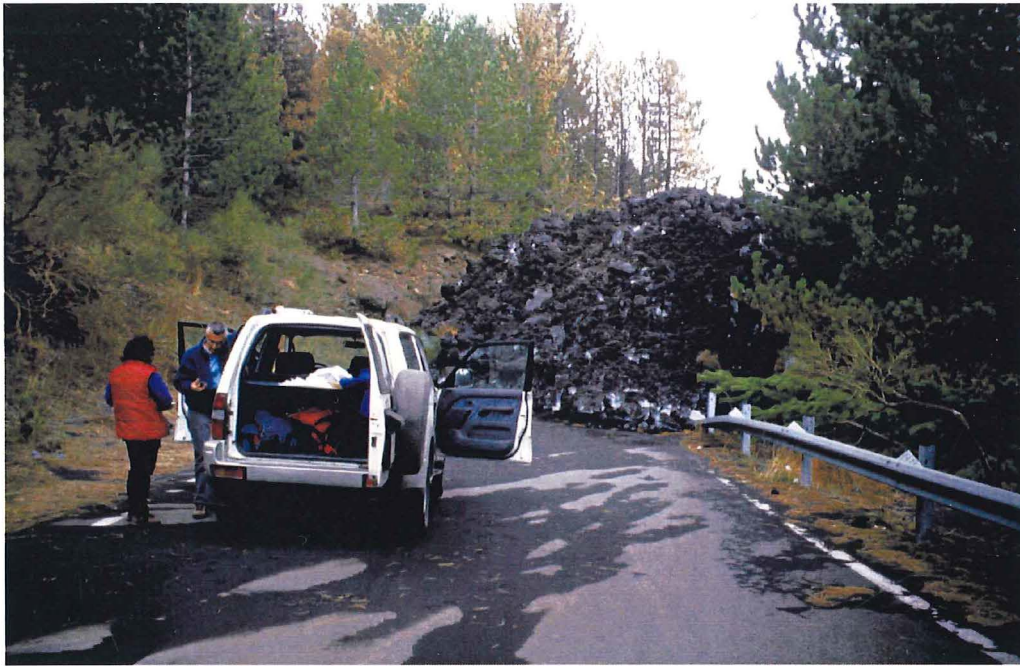
Figure 3.3 An aa lava flow in the Ragabo Forest destroys the road above Linguaglossa, November 2002

These same lava flows also threatened forests near Linguaglossa. However, although destructive, the slow movement of the flows (usually metres rather than kilometres per hour) allowed for mitigation strategies to be employed. An attempt to protect the pine forests was made by Ground crews from the Vigil de Fuoco (the fire department) and Corpo Forestale (the forest corps), as fires created by these flows could easily spread. These crews were supported by helicopters water bombing lava flows from the air (*L'unione Sarda*, 29/10/02). This strategy succeeded in restricting damage to that caused directly by the lava flows, stopping fires spreading far beyond the edges of those flows. Nevertheless over 80 hectares of forest were destroyed (*La Sicilia*, 2/11/02). In addition to the loss of forest, several roads on the slopes of the volcano were destroyed when 3m high aa lava flows passed over them (Figure 3.3).

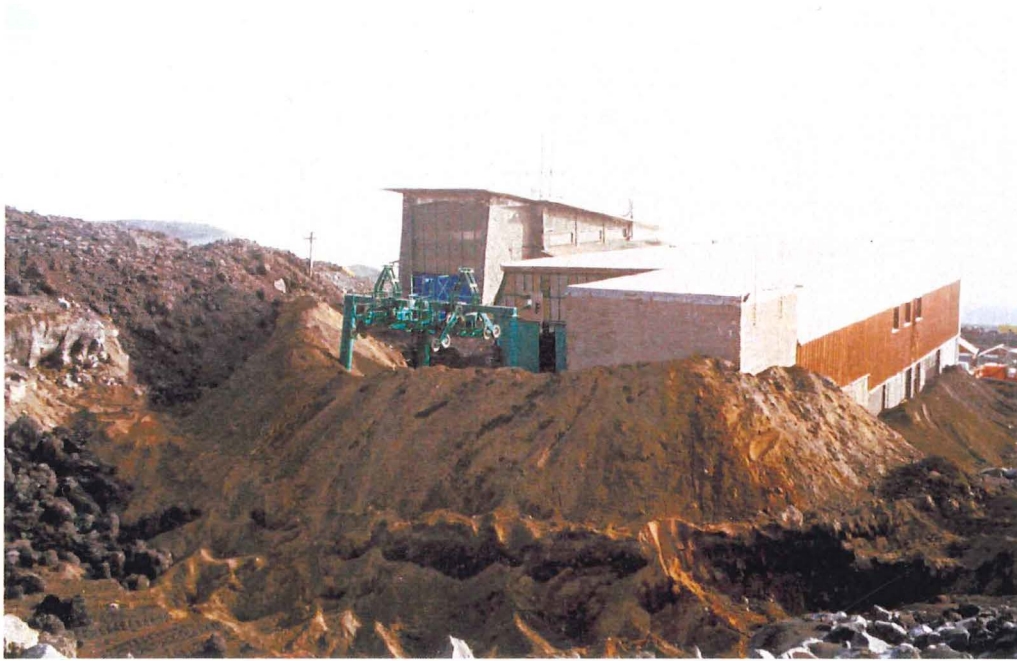
Figure 3.4 Earthworks around the ski lift station at Rifugia Sapienza, November 2002. Note the lava flow to the left of the picture

Creating earthworks to divert lava flows has in the past been employed with some success on Mt. Etna, attempts at this strategy were again made during the 2002 eruption. The flow that approached Rifugia Sapienza on the night of 24 November was successfully diverted by directing it slightly to the east to protect the ski station (figure 3.4)

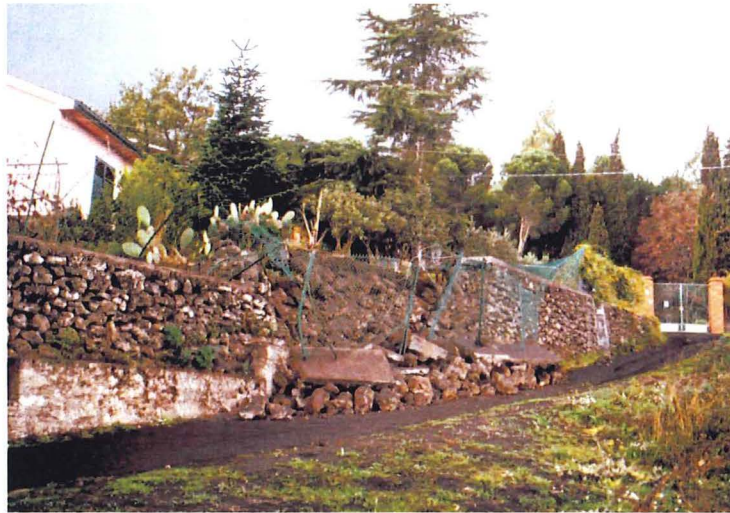
Figure 3.5 Collapsed retaining wall in Monacella, November 2002

Dry stone retaining walls were a common casualty of the earthquakes, many of these had been constructed without building permits by local residents. The collapse of such features was common during these tremors (figure 3.5). However retaining walls constructed and maintained by local authorities alongside roads in the vicinity of Zafferana Etnea also suffered partial collapse. Road surfaces were affected as well, cracks formed and disaggregation of the seal took place in some areas. Further damage occurred to roads as a result of small landslides near Piano Provenzana.

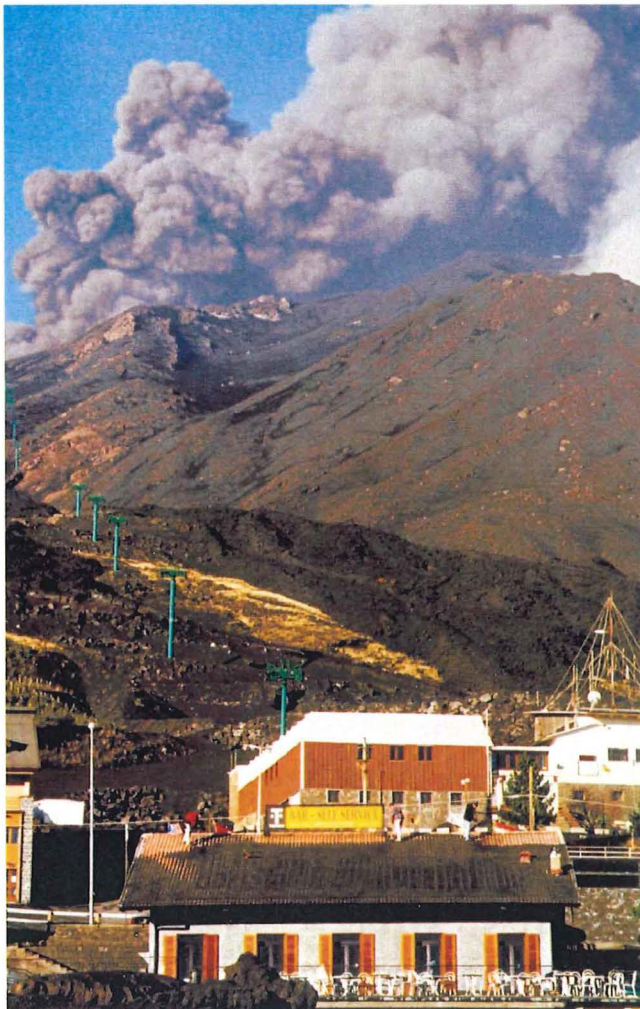
Figure 3.10 Rifugia Sapienza November 2002. In the foreground workers clean the restaurant roof while the eruption continues in the background

such as Rifugia Sapienza. (This is not including the Torre del Filosofo observatory, which was buried under a scoria cone built around the active vent). Ashfall was usually not continuous in any one area for more than a few hours during the course of the eruption. This was due to either changes in wind direction, or the waxing and waning of the explosive activity. This usually gave residents time to clean ash from roofs between ashfalls. However in the case of some badly maintained buildings, flat or slightly pitched roofs that were not cleaned accumulated sufficient ash to cause collapse after rainfall saturated them (P. Del Carlo, *pers. comm.*, 2002). Minor structural damage also occurred on houses with pitched roofs that were not cleared of accumulated ash. Although Sapienza was subject to the heavier ashfalls than more distal urban areas, the structures in this resort were designed to cope with snow loading, being situated at 1900m above sea level. In addition, regular cleaning of roofs meant that buildings in this area did not experience damage from ashfall.

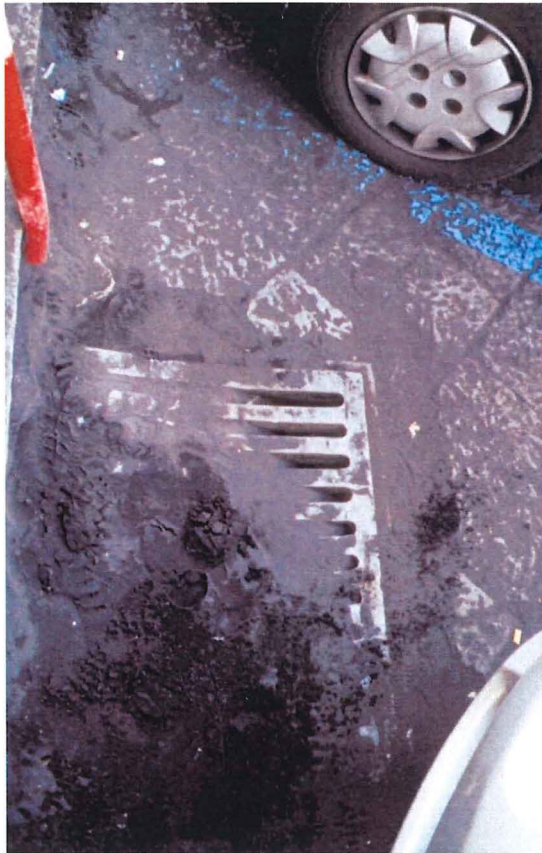
Figure 3.11, Ash blocking Stormwater drains in Catania, November 2002

The influx of ash into the stormwater system proved to be a problem for drainage in Catania. Siltation effectively blocked some drains completely, and restricted flow in others. Combined with rain, this resulted in localised flooding on several occasions, which affected traffic flow when roads became submerged. Fortunately there was little heavy rainfall in Catania during the course of the eruption. No problems with sewerage were reported, though little data could be gathered on this subject due to some communication (language barrier) problems during fieldwork. INGV staff were unaware of any damage to infrastructure or blockages of actual sewerage pipelines. It was their understanding that sewerage was flushed directly out to sea without any kind of treatment, though this is unverified (P. Del Carlo, *pers. comm.*, 2002). Figures 3.11 – 3.14 illustrate the effects of ash on the streets of Catania.

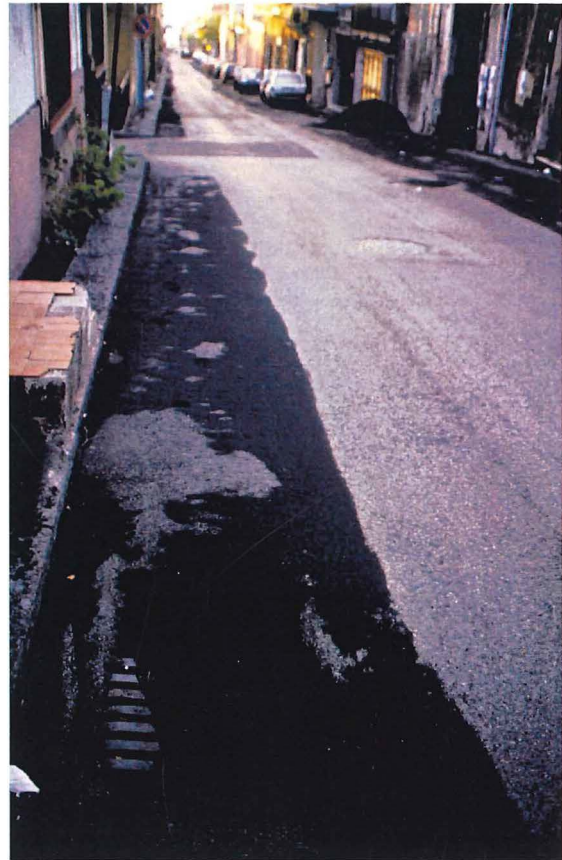
Figure 3.12 Ash blocking Stormwater drains in Catania, November 2002

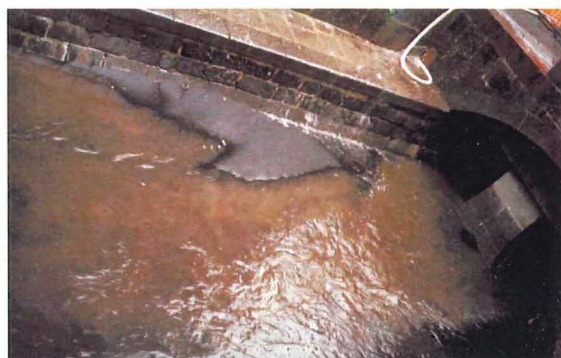
Figure 3.13, Siltation seen in open stormwater drains in Catania, November 2002

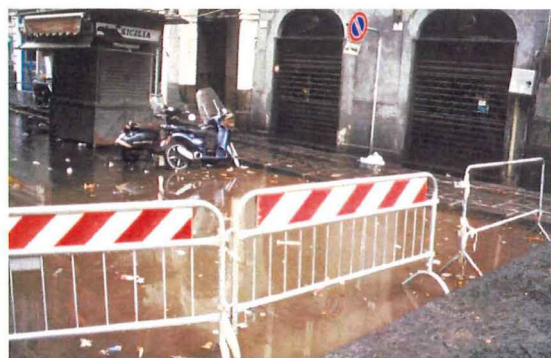
Figure 3.14 Flooding as a result of ash blocking drains, Catania, November 2002

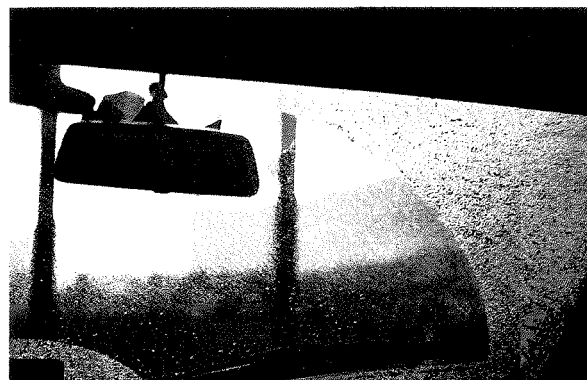
Figure 3.15 Light rain and light ash were easily coped with by vehicle windscreen wipers

Wet ashfall presented different problems. Although water prevented the ash from being stirred up into clouds, during heavy ashfalls the rapid accumulation of ash on windscreens directly inhibited visibility. In lighter ashfalls windscreen wipers were able to effectively clean windscreens (figure 3.15). However during heavier falls it became necessary to frequently stop vehicles every few hundred metres and manually clean windscreens, using bottles of water to clean off the finer particles.

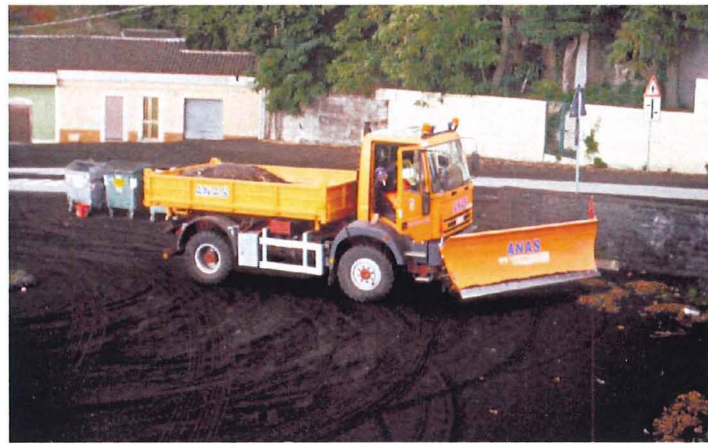
Figure 3.16 Clearing ash off roads in Monacella. Snowploughs proved effective at quickly cleaning deposits of several millimetres off roads.

at speed could cause damage to vehicles or even accidents to occur. At times larger drifts blocked roads altogether until mechanically removed. While dry ash was removed from roads with the use of road sweepers, the removal of ash that had been dampened or wetted entailed using machinery such as snowploughs and front-end loaders. In urban areas ash was swept more regularly, with both road sweepers and workers with brooms (figures 3.16 & 3.17).

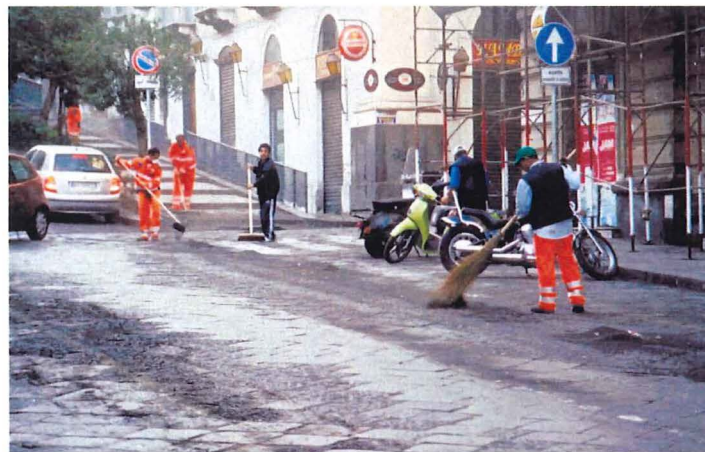
Figure 3.17 Council workers sweep ash from streets in Catania

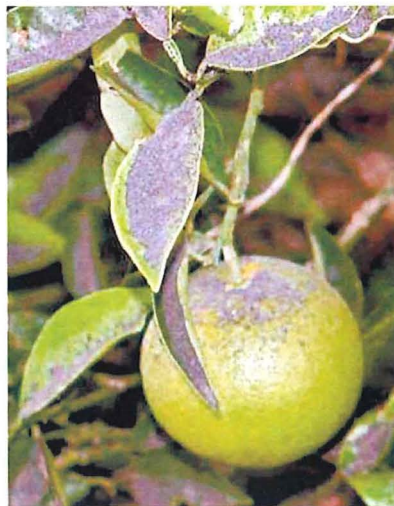
Figure 3.18 Citrus fruit damaged by ashfall (photograph from "La Sicilia" 6 November 2002)

Fruit and vegetable growers were perhaps the hardest hit economically. Ashfall damaged fruit and drastically reduced its value. Almost one third of Italy's oranges are grown in the region of Catania, along with other citrus fruit, (*La Sicilia*, 09/12/02). 50% of these were lost, ruined by both ash pitting the skin and being absorbed into the fruit (*La Sicilia*, 29/10/02).

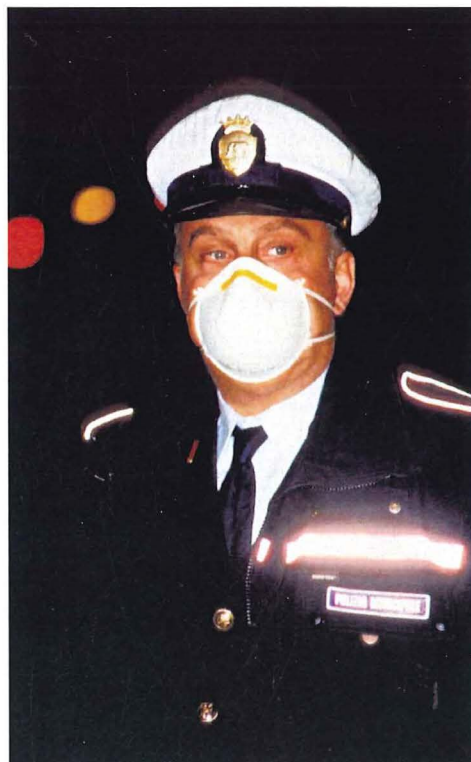
Figure 3.19 A municipal police officer in Catania wearing an ash mask while on traffic duty

The short-term effects of the basaltic ash on the regions inhabitants were largely of discomfort, rather than anything serious. Ash getting into peoples eyes was both painful and difficult to remove. It did have the potential to scratch the cornea if eyes were rubbed as opposed to being washed out with water. The wearing of masks to filter out ash particles was a common sight in Catania during the course of the eruption (figure 3.19).

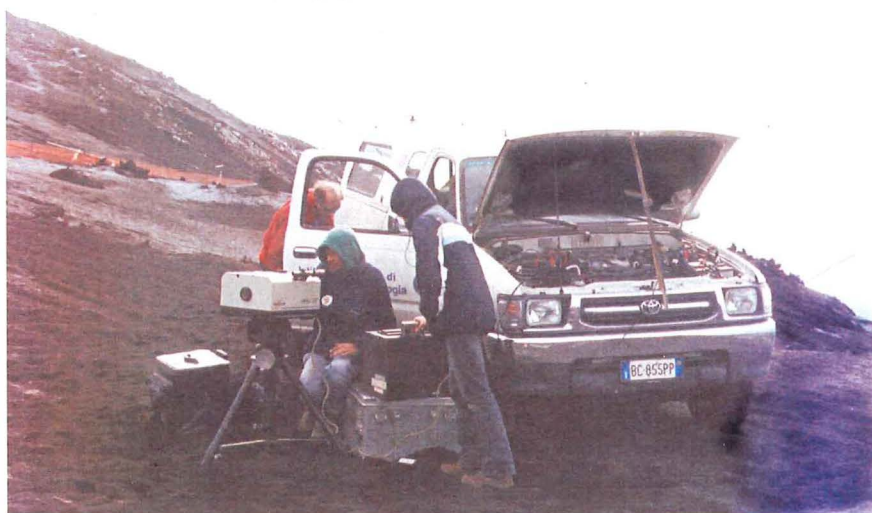
Figure 5.1 INGV staff take IR spectrometer readings on Etna 2022. Note the ash-covered track used to access site

(amongst others) regularly climbed from Rifugia Sapienza to the active craters approximately 700 m higher, using a 4wd track that was regularly covered in ashfall. Thick ash deposits tens of centimetres deep that were not part of tracks were also driven upon without difficulty.

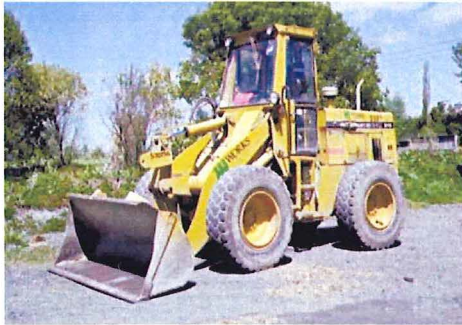
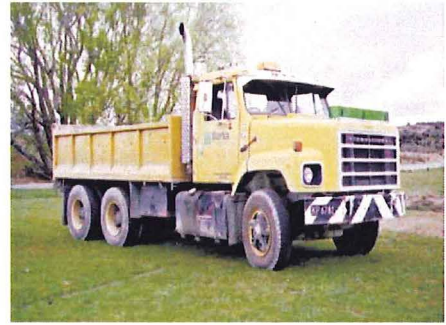
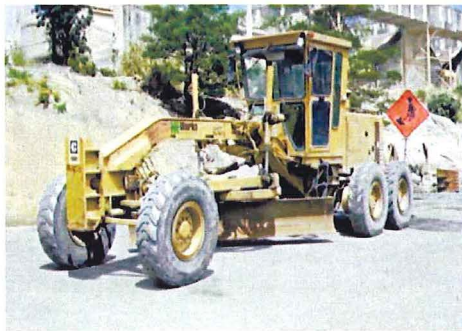
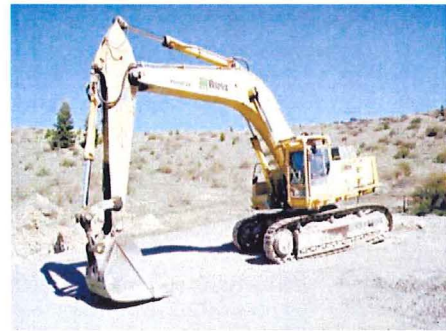
Figure 5.2 Works Infrastructure equipment available to clear ash from roads. Clockwise from top left: loader, tipper, excavator, grader

(note, “super trucks” are general purpose trucks fitted with rotary brooms on the front, used for sweeping debris off roads)

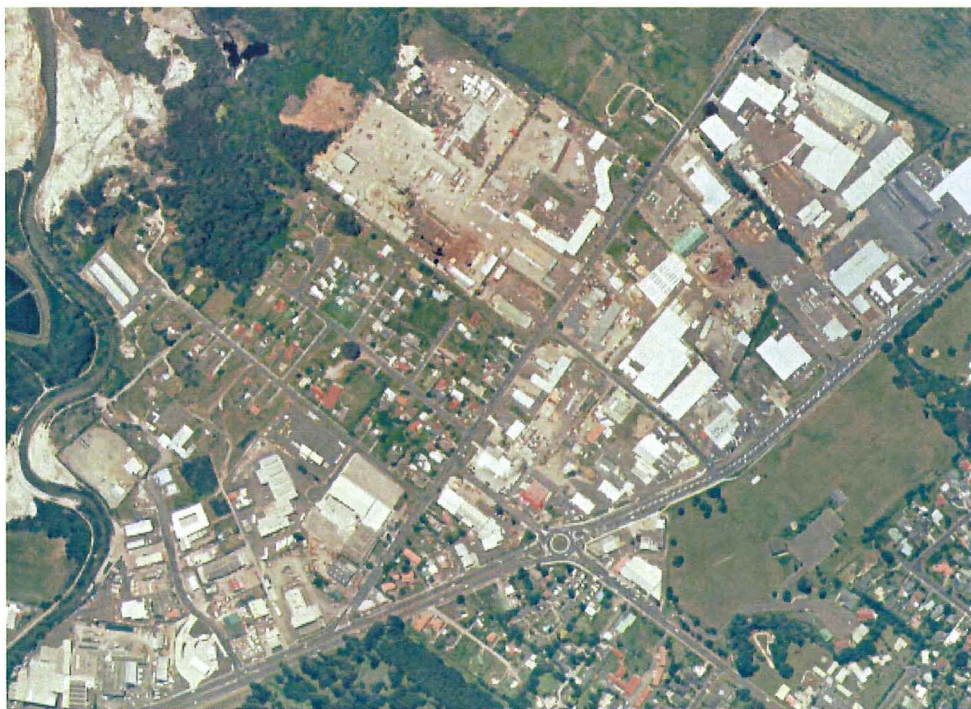
*Figure 5.5 Ngapuna, Rotorua. Note the many large span low pitched or flat roofs of the industrial area.
(Photograph courtesy of Rotorua District Council)*

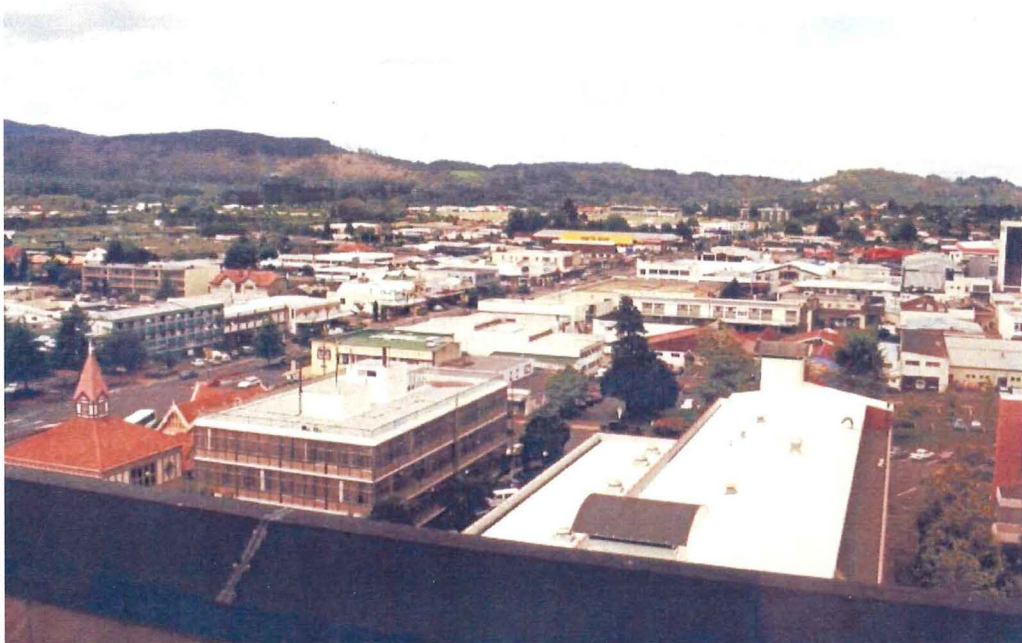
Figures 5.6 (above) and 5.7. Central Rotorua, illustrating many flat and low pitched roofs in the CBD

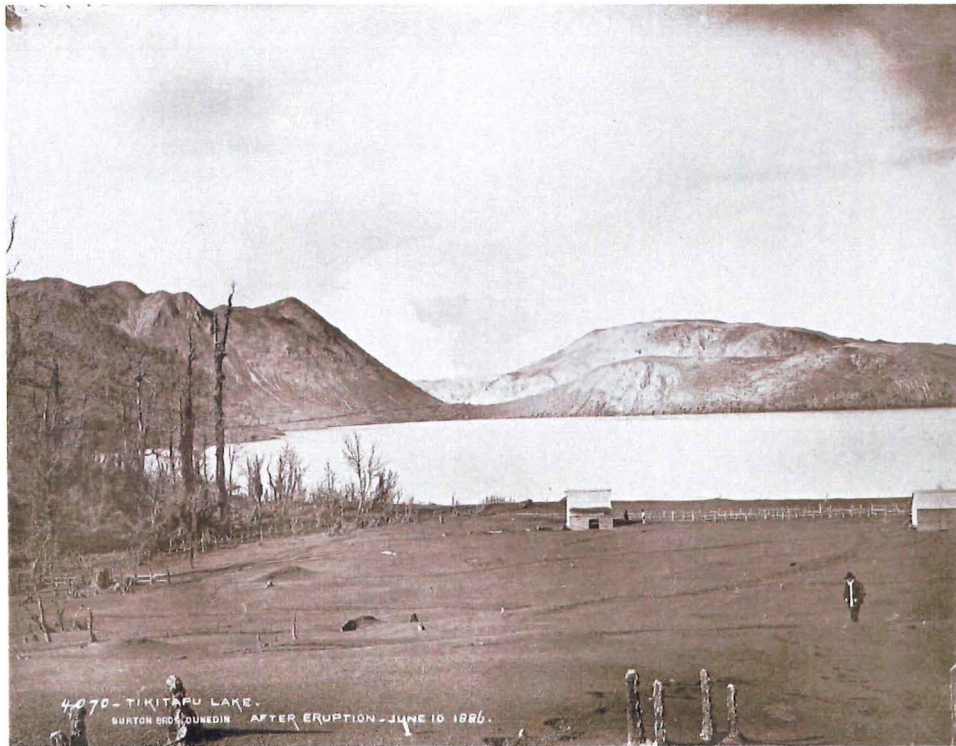
Figure 5.12, Tikitapu, 13 June, 1886 A. Ryan photograph

Ashfall alone is not likely to kill mature trees, but the accumulated weight of ash is likely to break large branches in proximal areas. Rees (1970) indicated that this is likely to occur with ashfall over 500 mm thickness. Over 1500 mm would kill all trees, under 500 mm would result in slight damage and partial survival of shrubs. These results were based on the Parícutin eruption of 1943-52. Egglar (1963, cited in Blong 1984) also studying the Parícutin eruption noted that pine trees with basal diameters from 100–300 mm had the best rates of survival. This was because the trunks/branches were strong enough to resist excessive bending, but flexible enough to dump part of the ash load. The 1886 Tarawera eruption also gives a good indication of likely damage to trees. Even at 8 km from the Rotomahana section of the fissure, trees in Te Wairoa were completely defoliated by the ash, lapilli and mud. Trees here had bark stripped off the east side (facing Rotomahana), even though they were 2 km beyond the extent of base surges (Keam, 1988). Partly buried trees such as kamahi and tawa quickly resprouted though, some even producing seed the next year (Clarkson & Clarkson, 1991). To the northwest of Tarawera the 500 mm ashfall isopach almost reaches Lake Tikitapu, 11 km from the fissure. Thicknesses here were estimated by surveyor Henry Roche to be about 45 cm (Keam, 1988). The effects of ashfall here were a little more severe than the “slight damage” description given by Rees (1970) for this depth of ash. Photographs show that all trees are completely defoliated, several have fallen or lost branches (figures 5.11 & 5.12). It should be noted however that fallen trees in this area are attributed not just to ashfall, but also to strong winds that were blowing that night.

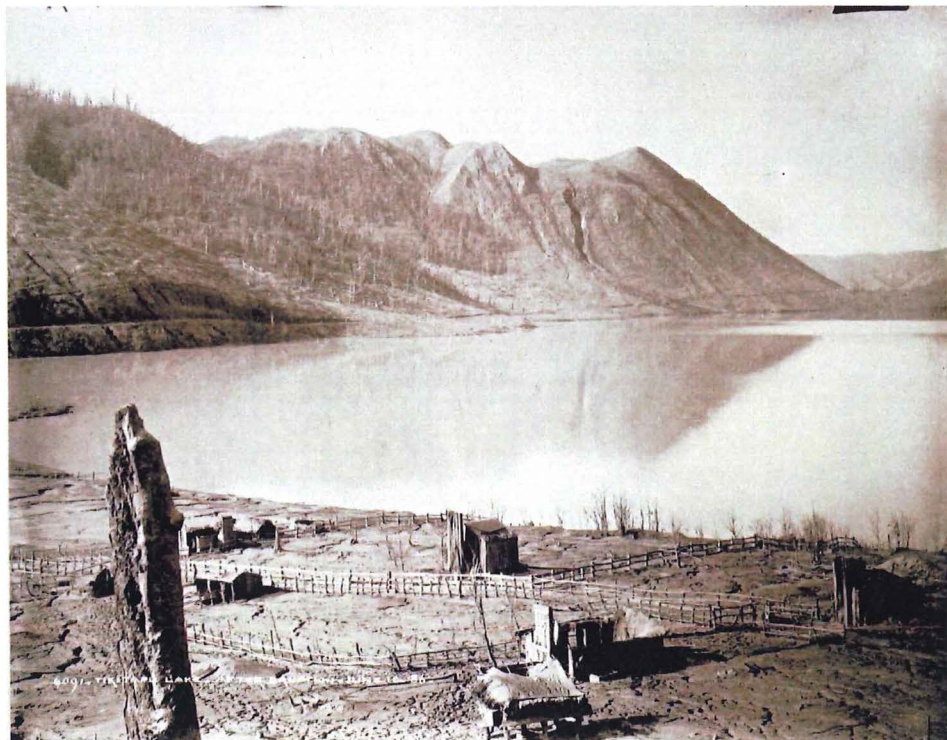
*Figure 5.13 Tikitapu, July-September 1886 Burton Brothers photograph.
Note defoliated trees on the slope to the left of the lake*
